Geotechnical state-of-the-art in Guatemala -- Ground stabilization

GEOTECHNICAL STATE-OF-THE-ART IN GUATEMALA – GROUND
STABILIZATION

A DISSERTATION

DOCTOR OF ENGINEERING
In
GEOTECHNICAL ENGINEERING

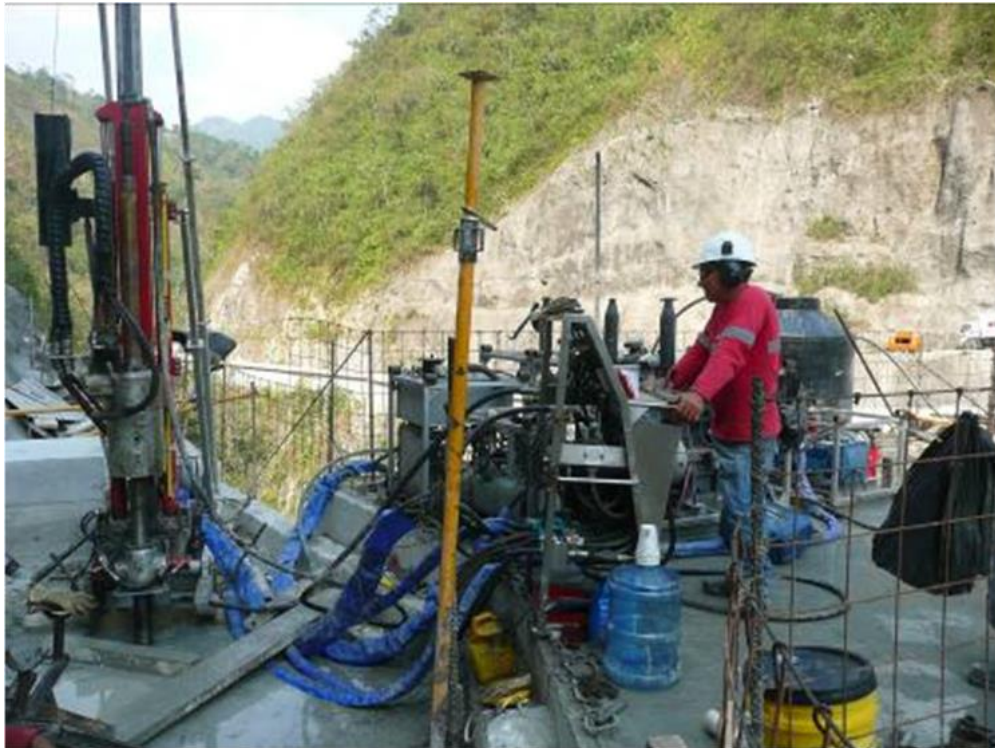
Figure 4.30. Drilling from the surface using wire line system

4.2.5.3. Drilling. Due to access and site conditions, different types of drilling equipment were used. For drilling within the service galleries a Longyear LM-55 electric drill equipment, no combustion, were used. For the drilling from the dam surface an Ingetrol Explorer MD3 hydraulic equipment were used. Rotary core drilling system was used in order to avoid damage the concrete of the dam. Core drilling also allows to verify ground stratigraphy. Boreholes were drilled in NQ diameter, hole (outside) diameter: 75.7 mm; core (inside) diameter: 47.6 mm. Figure 4.30 shows drilling process with the Ingetrol Explorer MD3 equipment.

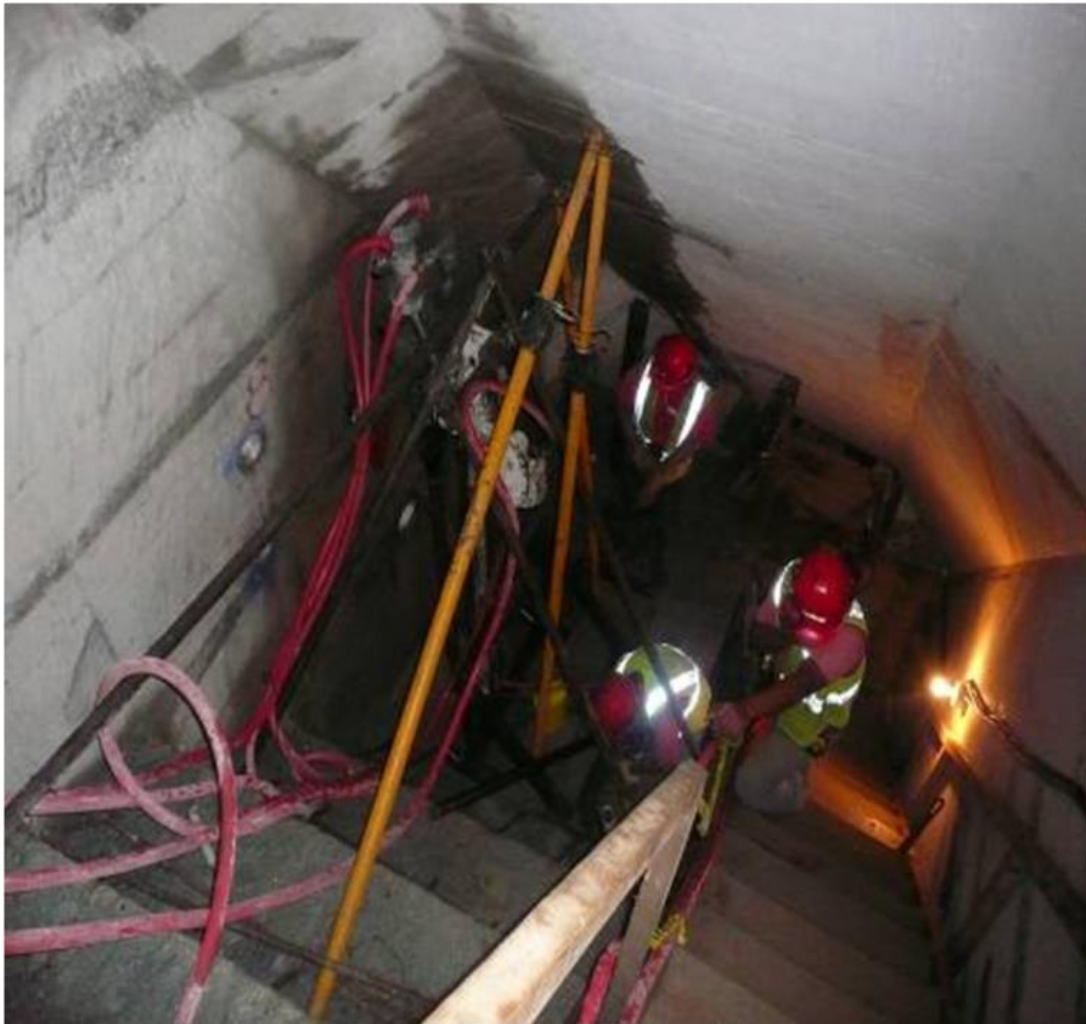
Figure 4.31. Grouting from access gallery using wire line system

4.2.5.4. Grouting. The first step for grouting is mix preparing. The mix was prepared by two Cemix grout fabrication station manufactured by Atlas Copco. The grout station was equipped with a high speed mixer of 100 liters capacity a high turbulence agitator of 200 liters capacity and an endless screw type grouting pump capable to deliver 120 liters / min at pressures between 800 and 5,500 kPa. The equipment is driven by electric motors and the electro system is controlled by automatic

valves. An automatic recording equipment Lutin model NX-B53 manufactured by Jean Lutz was used to control the grouting pump. This unit was calibrated for recording pressure, volume and flow, being programmed to use three curves GIN system parameters. This type of recorder prints the results on paper and simultaneously recorded on a card that is used to download the information to a computer and graph the results of each step of injection. Grouting was performed in 3.00 m stretch using a single packer. A split-spacing method was used. Grouting sequence is first downstream line, upstream line and at the end the center line. Figure 4.31 shows grouting works within the service gallery and Figure 4.32 shows Lutin NX-B53 grouting control equipment.

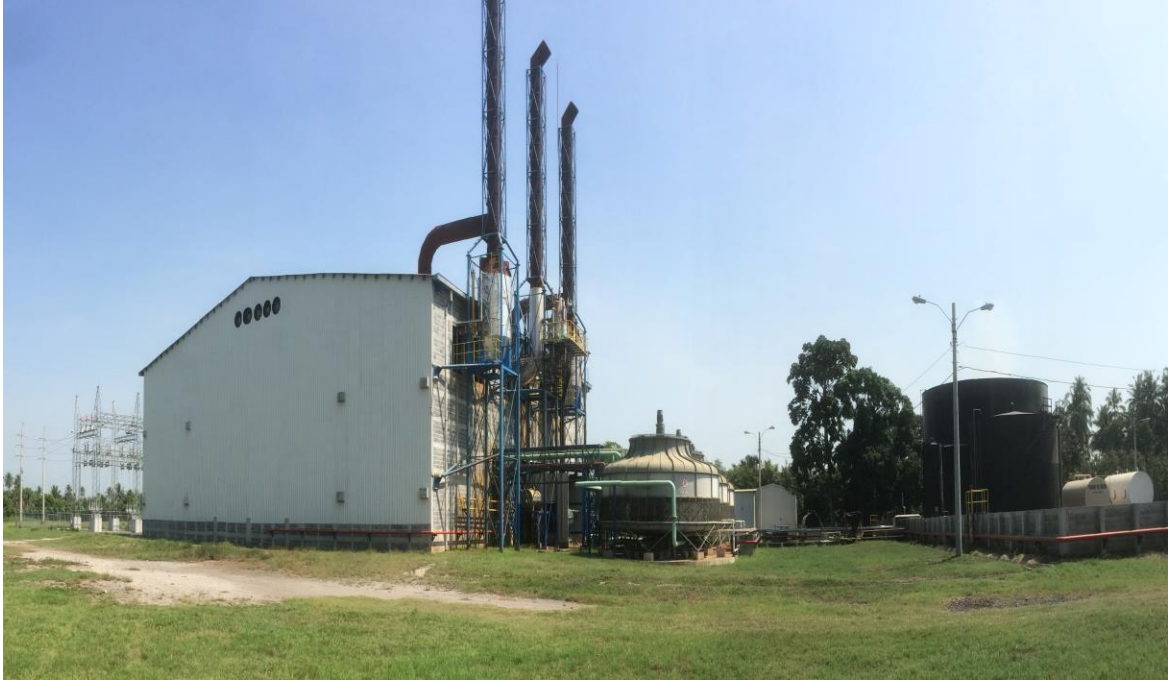
Figure 4.35. Panoramic view of Genosa Power Plant

The power plant consists of a main structure with three engines, auxiliary structures as cooling tower, electrical substation and a storage tanks area, Figure 4.35 shows an actual view of the power plant.

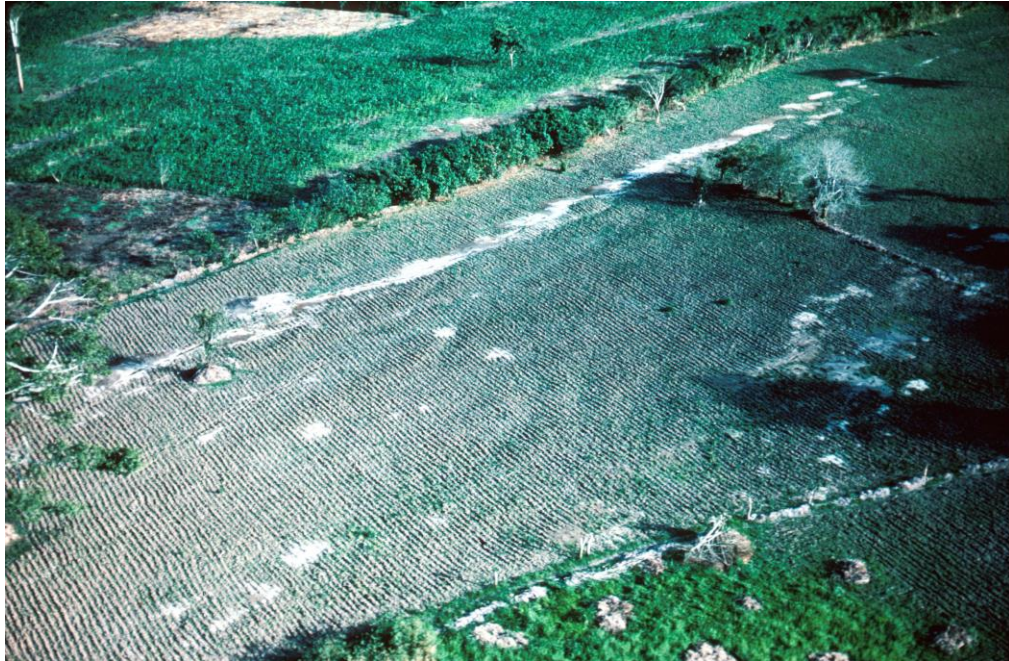
Figure 4.36. Sand blows located near to Motagua River during 1976 earthquake (Plafker, 1977)

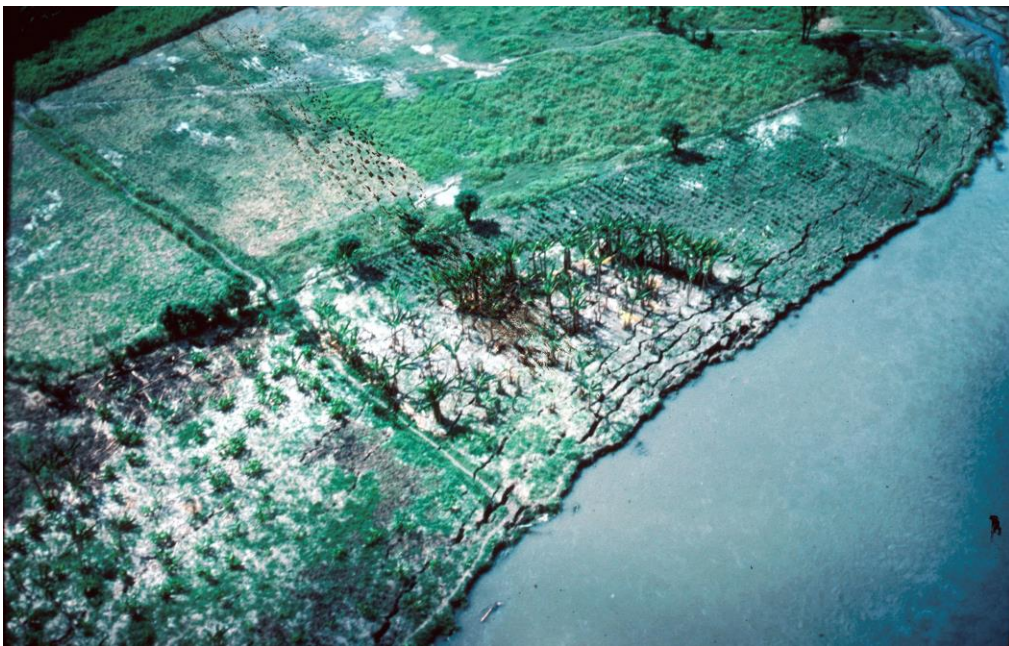
Figure 4.37. Flow liquefaction in a bank of Motagua River during 1976 earthquake (Plafker, 1977)

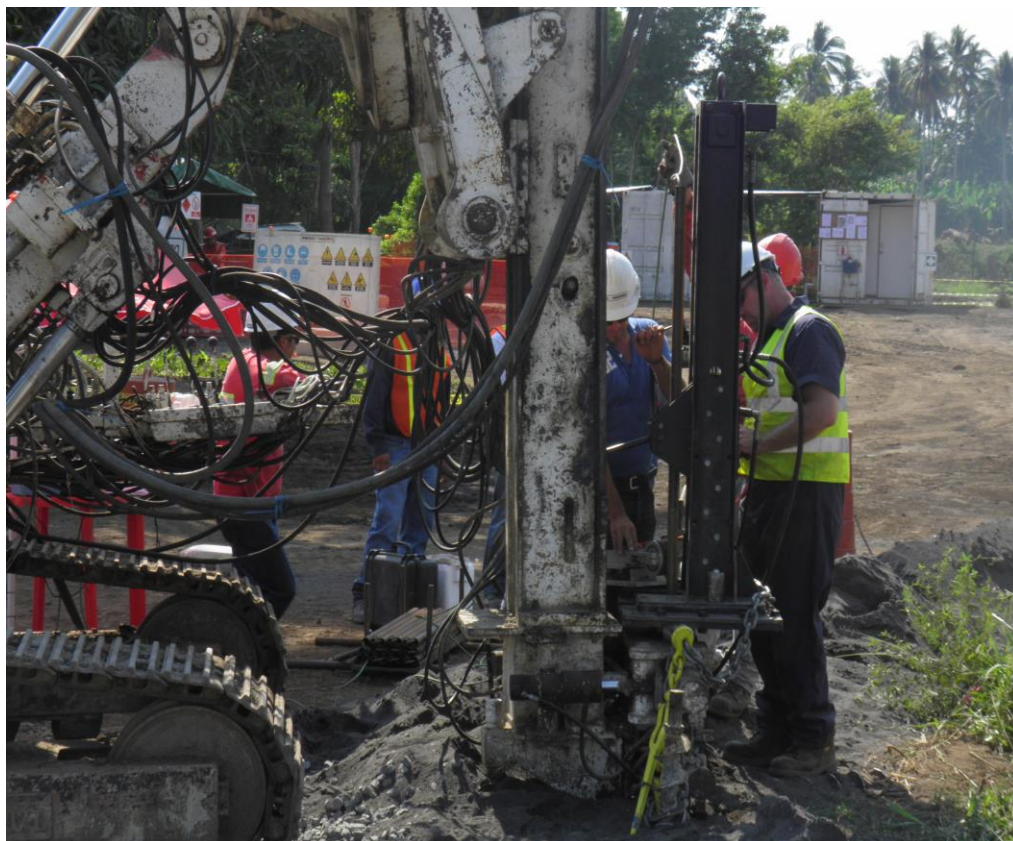
Figure 4.43. CPT performance

The Figure 4.43 show the performance of the CPTs and Table 4.13 shows a summary of the works performed.

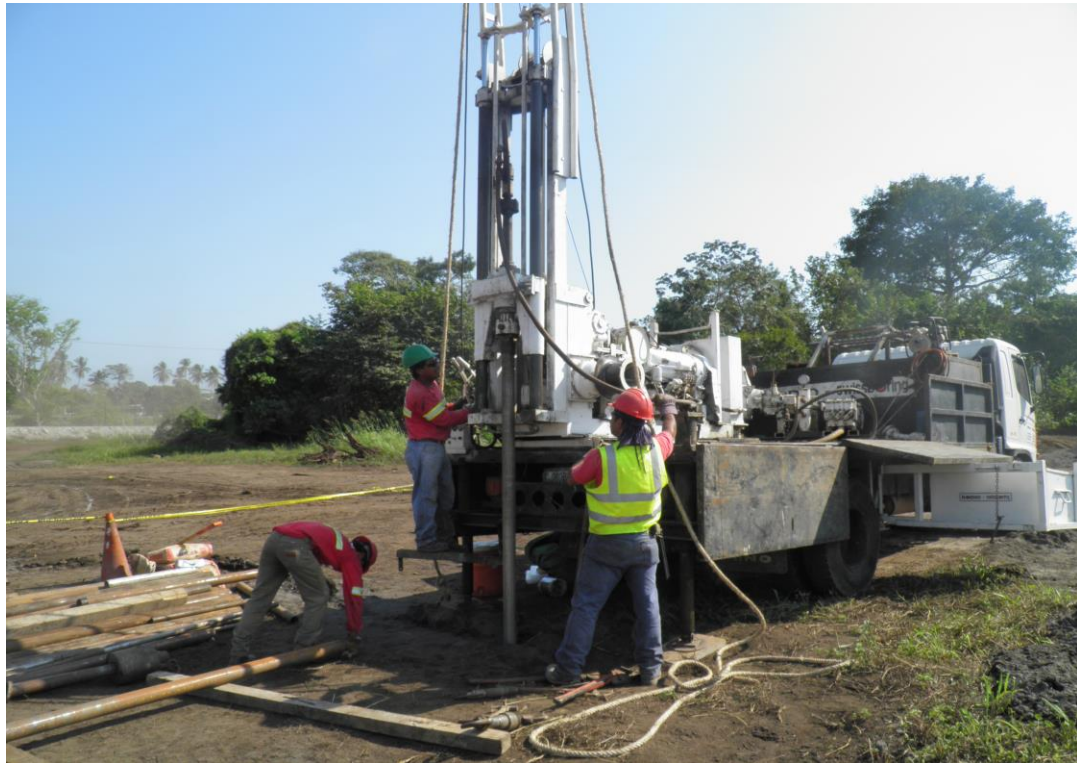
Figure 4.44. Borehole drilling using rotary core system

In order to complement the information from CPTs one borehole was drilled using rotary core drilling system in HQ diameter, hole (outside) diameter: 96 mm; core (inside) diameter: 63.5 mm. The borehole was drilled using a Mobile Drill B-57 drill rig, Figure 4.44 shows borehole drilling. From this borehole undisturbed samples from soft soil, were extracted using a Shelby tube, outside diameter: 50.8 mm; length 762 mm.

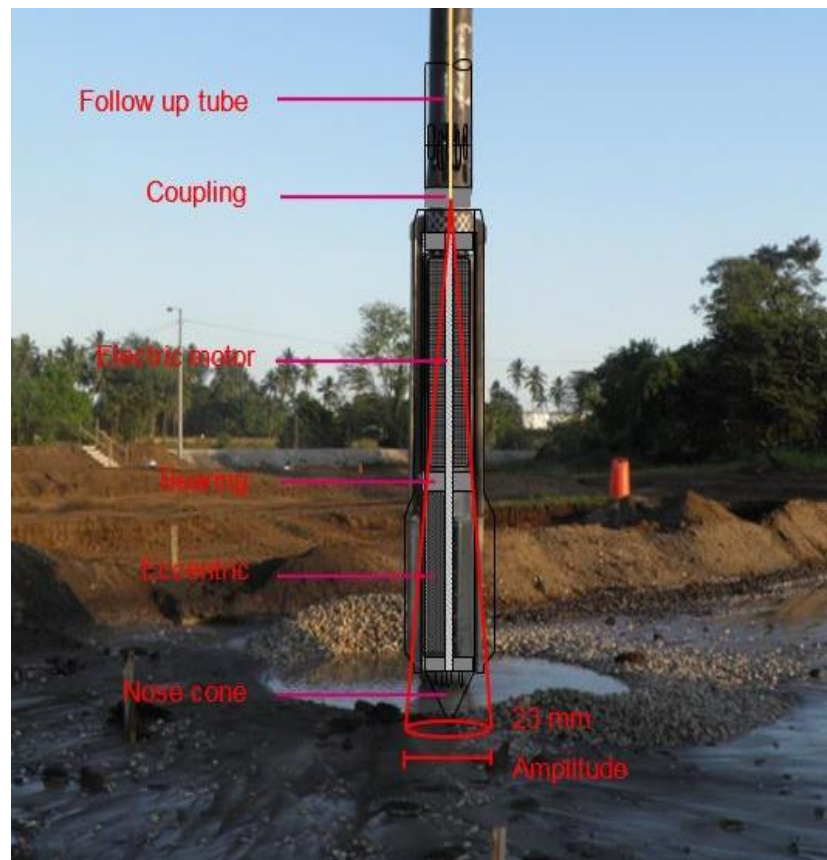
Figure 4.50. V23, Vibratroy probe schematic

The essential parts of the Vibroprobe are shown on the Figure 4.50. It is essentially a long slender steel tube with two parts: the vibrator and the follow-up tubes. The vibrator, the heart of the Vibratory Probe, consists of a hollow cylindrical body with 300-400mm diameter connected by means of a special elastic coupling to the follow-up tubes of a slightly smaller outside diameter. The characteristics of the V23 vibroprobe are summarized in Table 4.17.

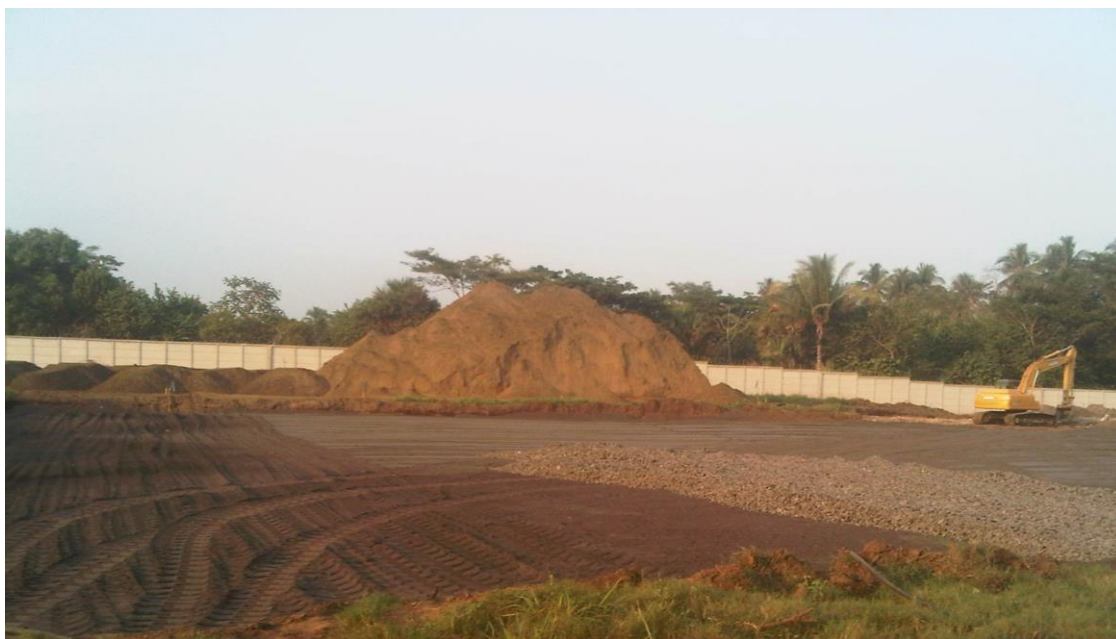
Figure 4.52. Working platform construction

The first step is prepare the working platform. This is very important in order to avoid accidents and allow a proper drainage of the area. The platform and accesses was compacted, drained and levelled in order to accommodate a crawler crane as well as the traffic of loaders required for stone delivery. The spoils and water generated by the stone column installation will be managed to maintain a clean working platform at all times. The working platform elevation was set at +0.50 m, at least 1.50 m above ground water elevation. The Figure 4.52 shows the work platform prior work start.

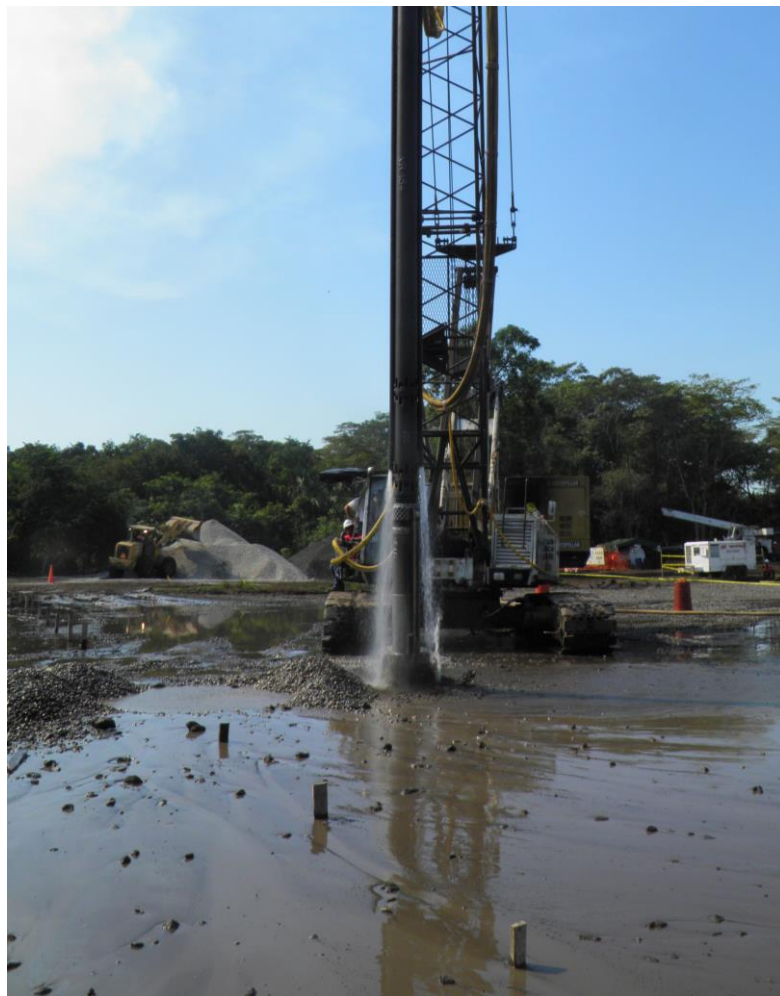
Figure 4.53. Vibroflot penetration

the maximum depth. When the vibroflot has reached again the full depth, the amount of water discharged from the tip of the vibroflot was adjusted so that the water level in the hole stays at about 1.50 m above ground water table or at working platform level. This ensures the stability of the hole. The figure 4.53 present de vibroflot penetration using water and air jet.

Penetration is stopped at the design depth or upon refusal on very dense sandy layers or very stiff clayey layers or big elements. Refusal was defined in the following way: the intensity in the electric motor of the vibroflot reaches values in excess of 200/250 A and/or penetration becomes slower than 0.50 m per minute, whichever comes first.

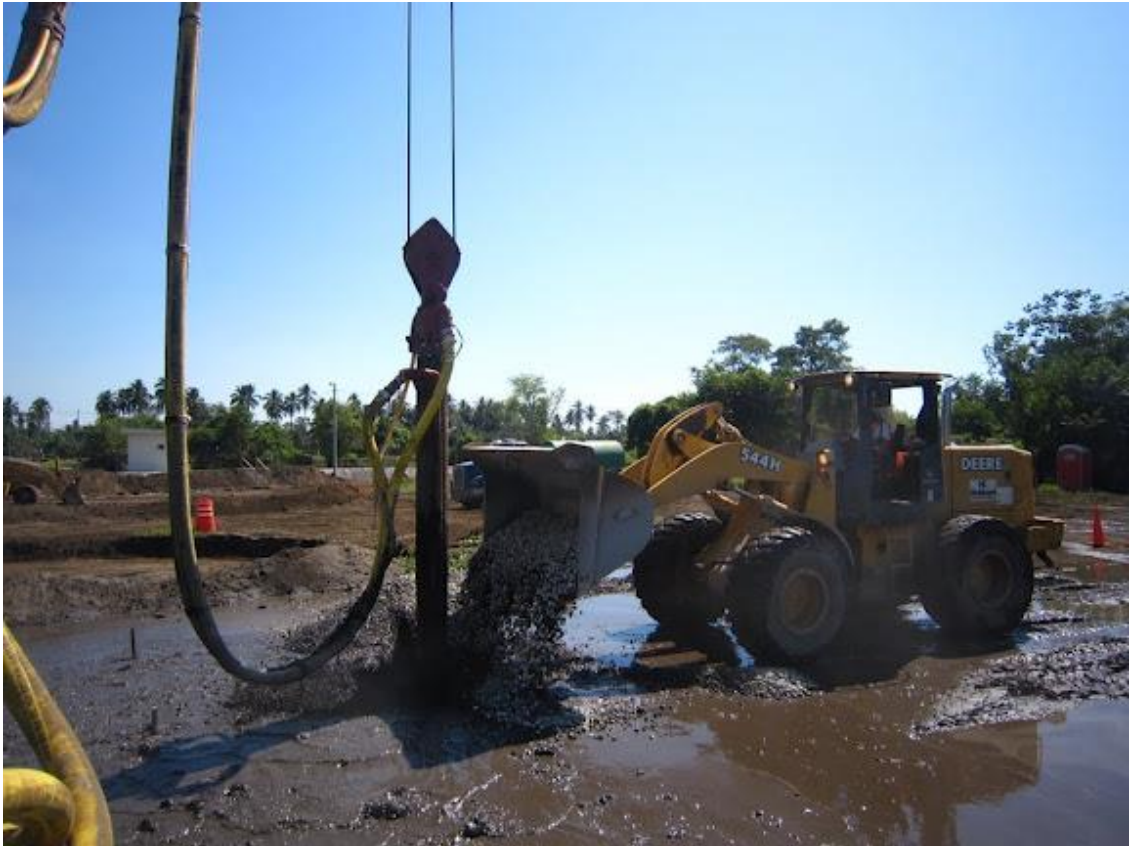
Figure 4.54. Gravel filling and compaction

2 - The vibroflot is then lifted by 0.50 to 1.00 m, and coarse gravel or crushed stone is tipped into the hole. The vibroflot is then either re-penetrated to within a short distance of the previously penetrated depth or held at the current depth until the amperage is reached, which is sufficient to produce the specified average column diameter or the required ground compaction. Radial forces produced by the vibrator force the added material horizontally out against the in situ soil, thereby compacting it. The process is repeated until the required volume of stone has been inserted or the required degree of compaction has been achieved. The Figure 4.54 show gravel filling and compaction process.

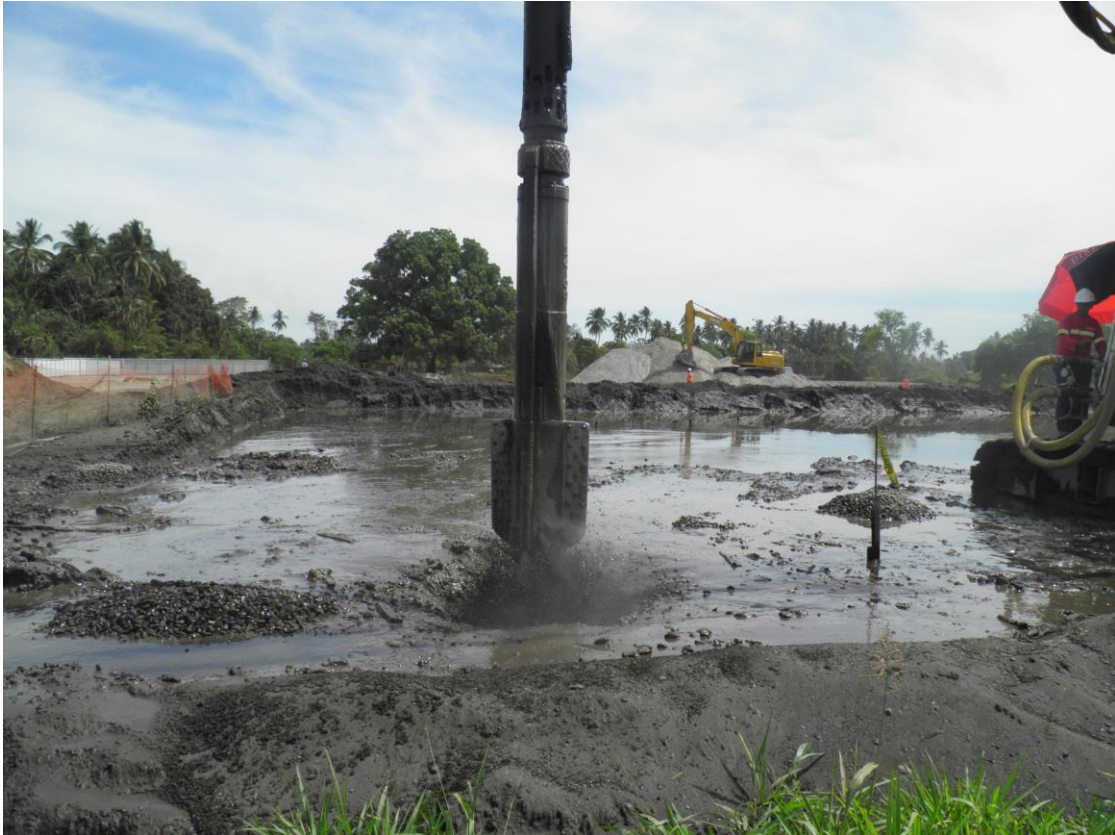
Figure 4.55. Final stage of the compaction process

3 - The filling / compaction cycle is then repeated in upward increments up to the working platform level or up to the upper level of the soft silty ground layers or lenses. During this operation, additional gravel or stone is added to the hole but without overfilling to avoid bridging of the gravel. In this manner dense granular material

interlocks with the surrounding ground and densifies it. The Figure 4.55 show final stage of the compaction process. Works were performed between 15th of January and 4th of February of 2012.

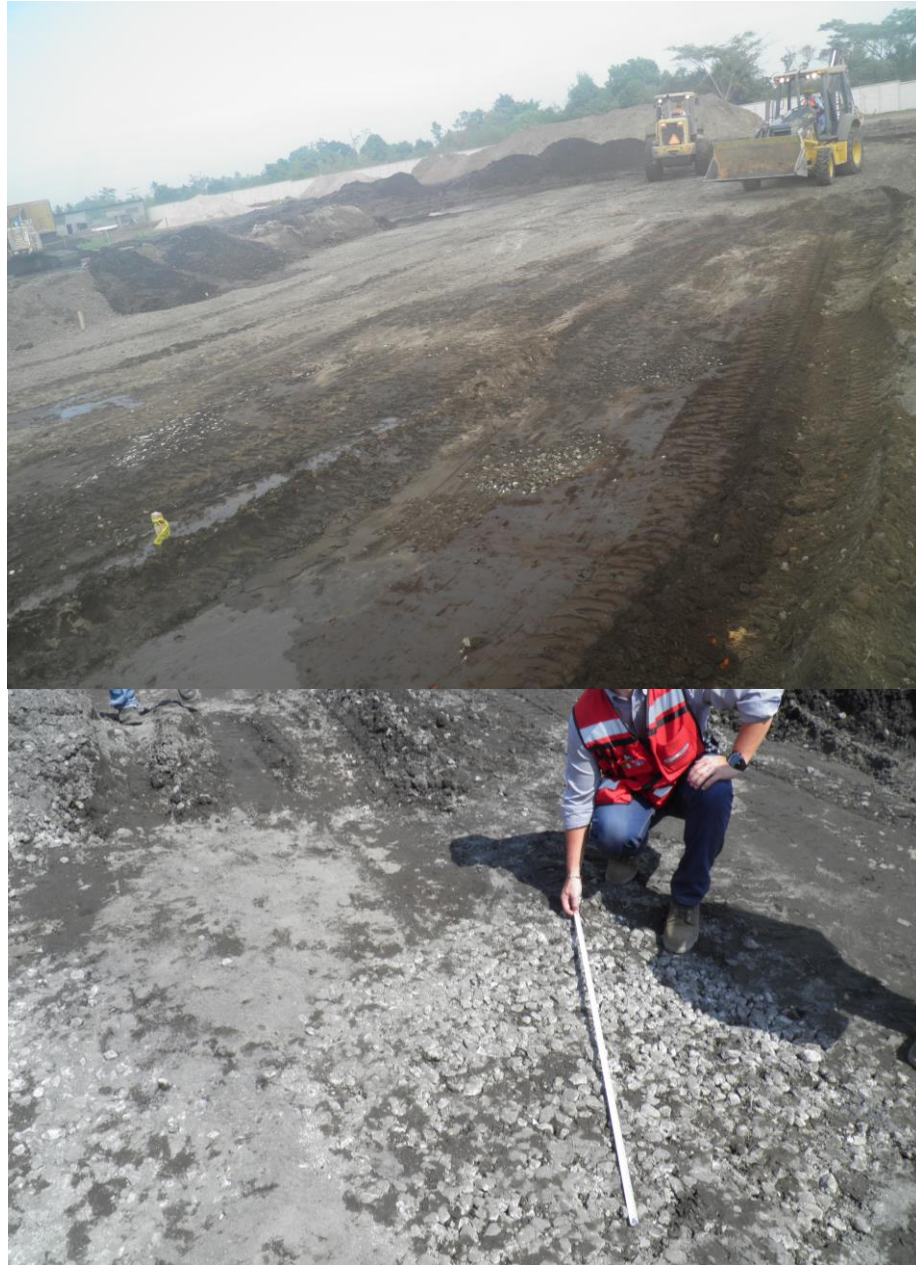
Figure 4.58. Trial area after striping

The stone columns were carried out considering this sequence: C170 to C168, C185 to C187 followed by C204 to C202 on the 20th and 21st of January of 2011. Post-CPT were carried out on the 26th of January after a rest period of 4 to 5 days to ensure dissipation of excess pore pressure. Spoils were removed and the former working platform was scrapped (30cm) in order to show up the top of the stone columns, Figure 4.58 shows trial area after striping.

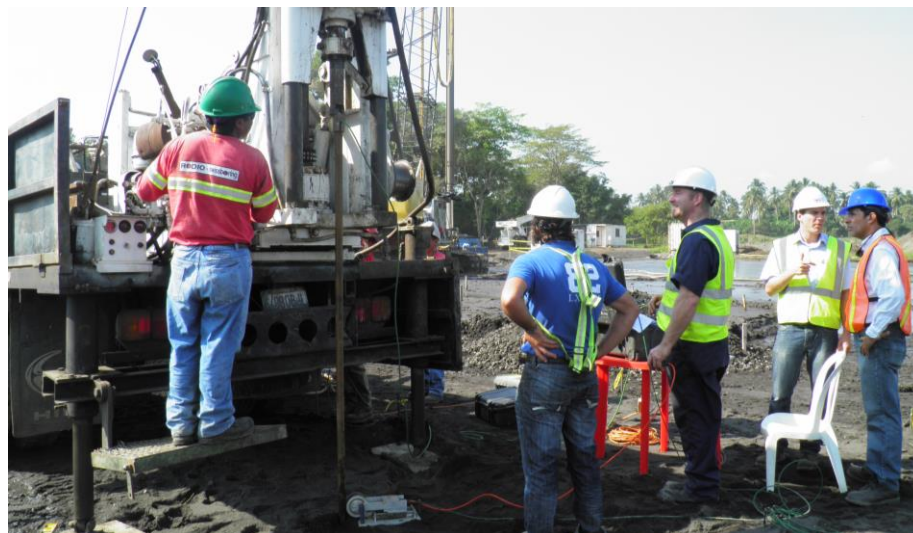
Figure 4.59. Post-CPTs performance

Initially, only 3 Post-CPTs were planned to be carried out as mentioned in the design section (Pre-CPTs 01 to 03) but due to early refusals found at shallow depth (1.00 to 2.00 m) for them, it was decided to immediately increase the number of tests to check that the very hard ground conditions of the first meters were homogeneous over the whole trial area, Figure 4.59 show Post CPT performance. Consequently, 2 additional

All Post-CPTs carried out within the trial area found refusal between 1.00 and 2.00m depth due to the very dense sandy material in the upper part of the profile regardless their location (weakest or mid-points).

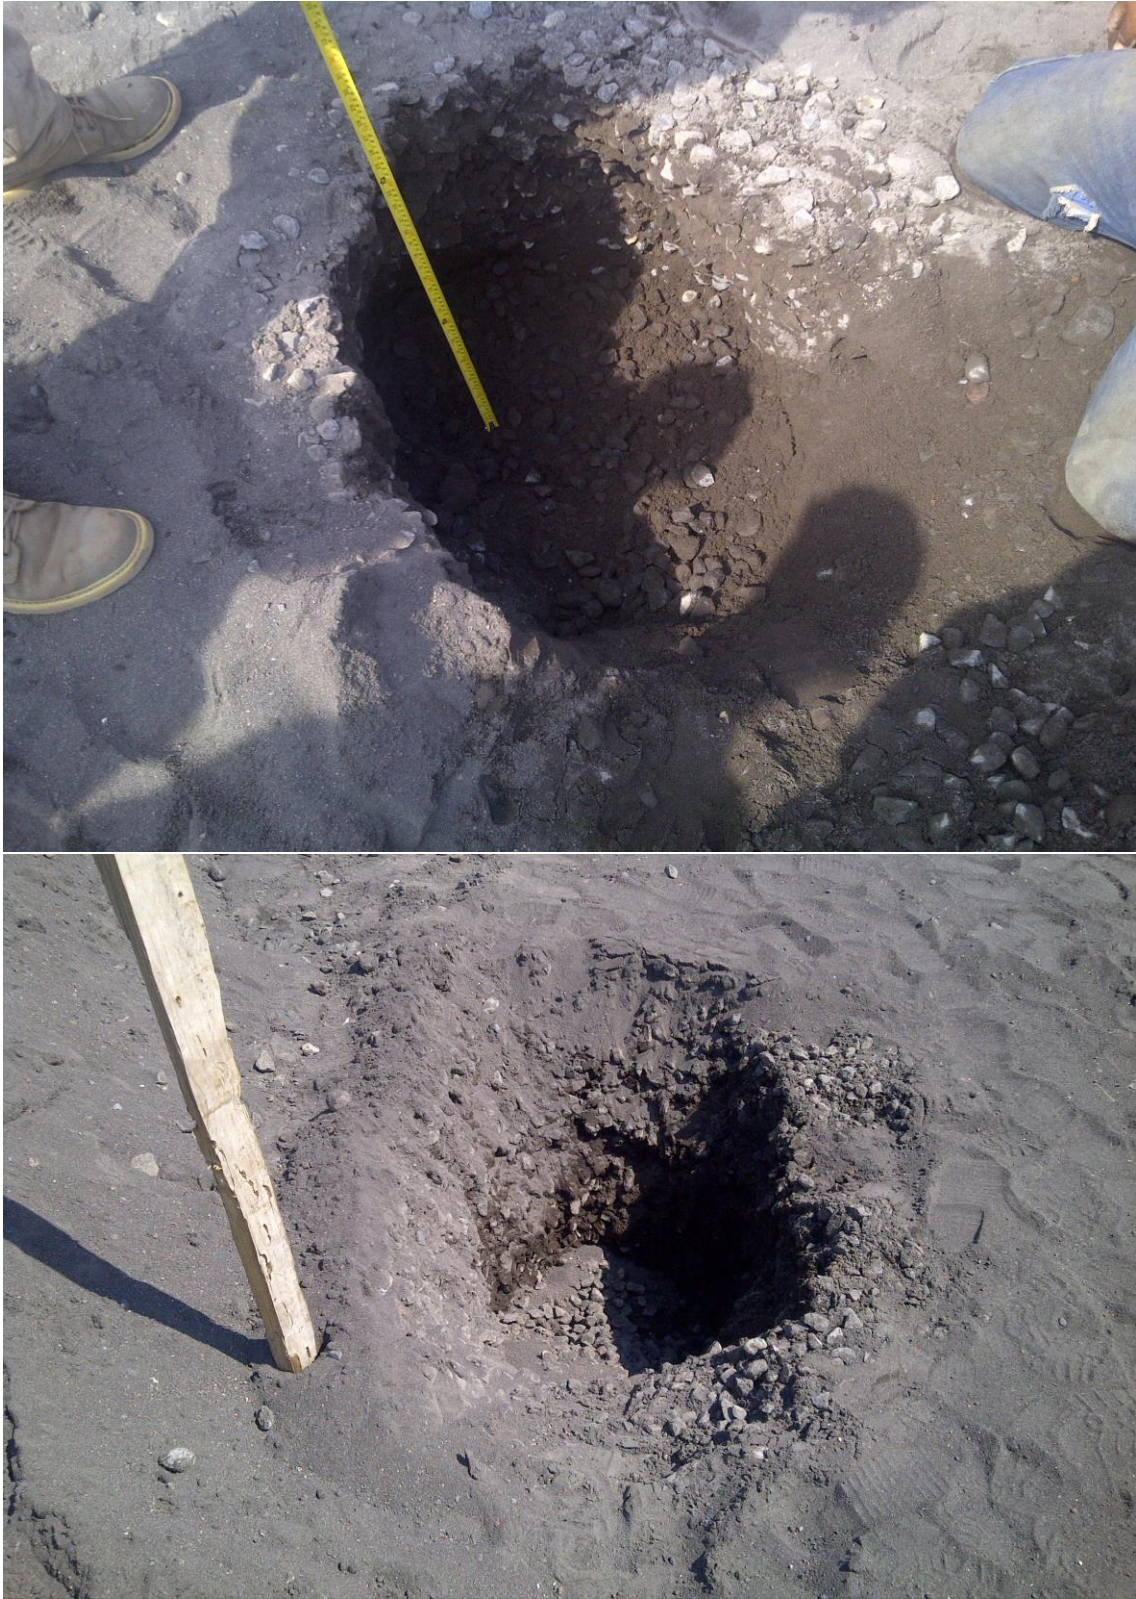
Figure 4.64. Construction Annomalies

4.3.5.7. Construction anomaly. After the works were finished, during scraping and conformation of the power plant final platform two holes, similar to sand blows were found. The holes have a depth between 60 to 70 cm and a diameter 80 cm. The figure 4.64 presents images of both holes.

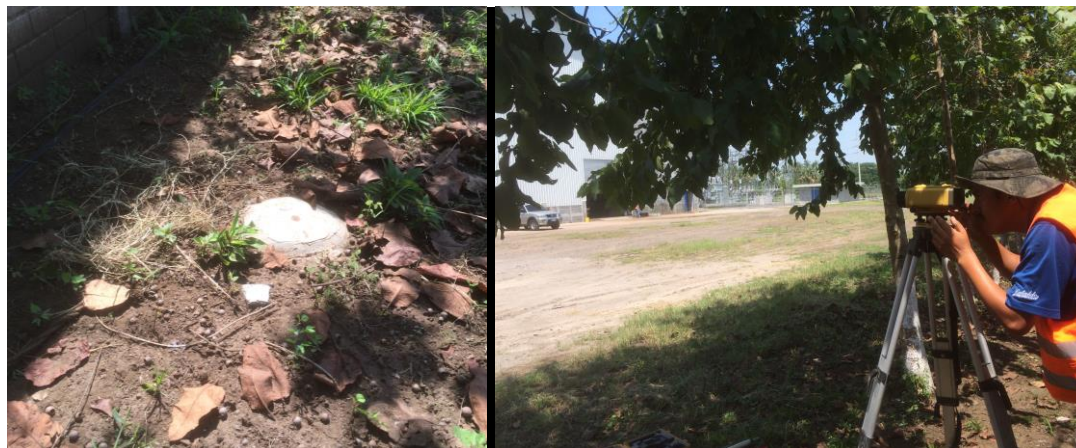
Figure 4.66. Survey monument and surveying works

Reading were performed using Topcon DL 102 Electronic Digital Level and a Nikon DTM 322 Total Station, Table 4.19 and 4.20 presents instruments characteristics, Figure 4.66 shows the survey monument and surveying works.
